Rehabilitation of Jointed Portland Cement Concrete Pavements: SPS-6—Initial Evaluation and Analysis

PUBLICATION NO. FHWA-RD-01-169

OCTOBER 2005

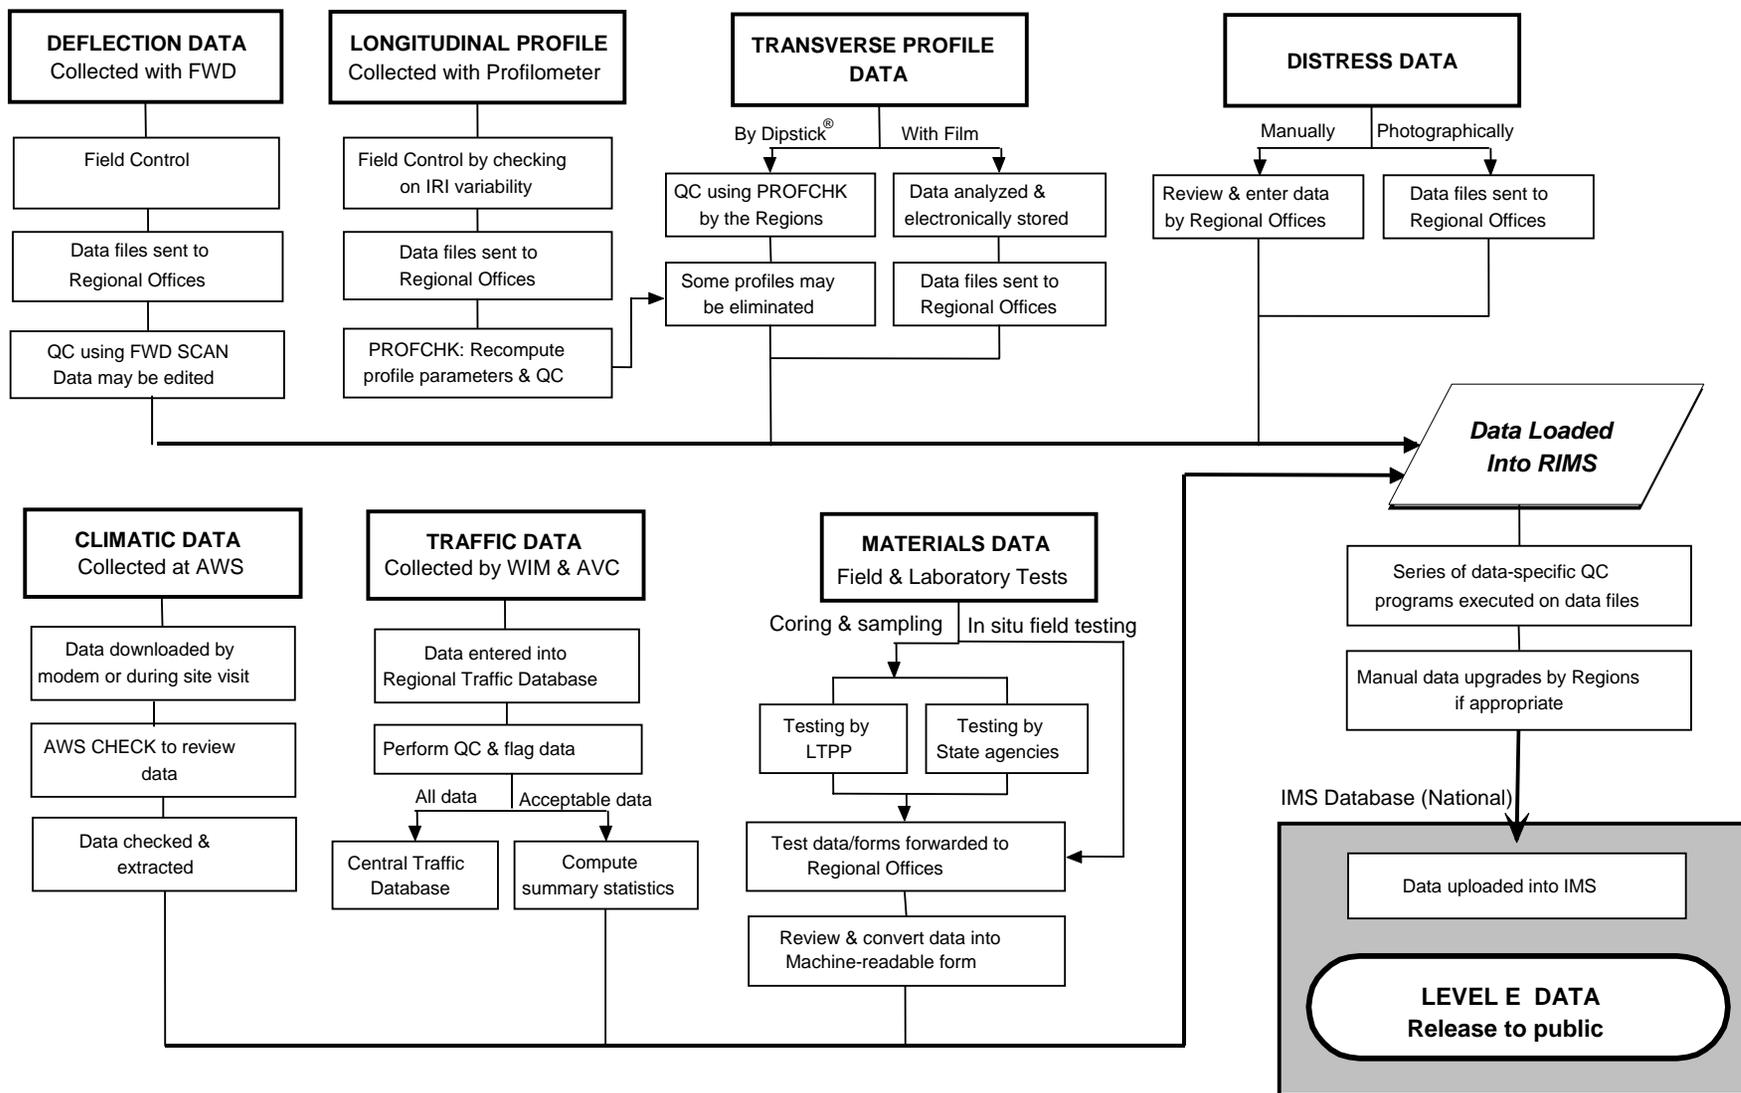
Figure 2. LTPP data collection and data movement flowchart.

Figure 2 provides a flowchart that shows the movement of the data elements and quality checks completed on the data prior to release to the public. Only a fraction of the data fields are checked. A value of “A” is automatically assigned to a record upon entry into the database. A value of “B” indicates that the QC process was executed and a level C check was failed. Any record for which correct section information is stored in the database is available after the quality check has been completed. A record of QC processing is included with the record. Since the checks are run in sequence from A through E, the last successful check is identified on the record as the record status variable. A value of “B” or “C” does not necessarily indicate that a higher level of quality check was unsuccessful, merely that a necessary data element was not available when the quality check was done.

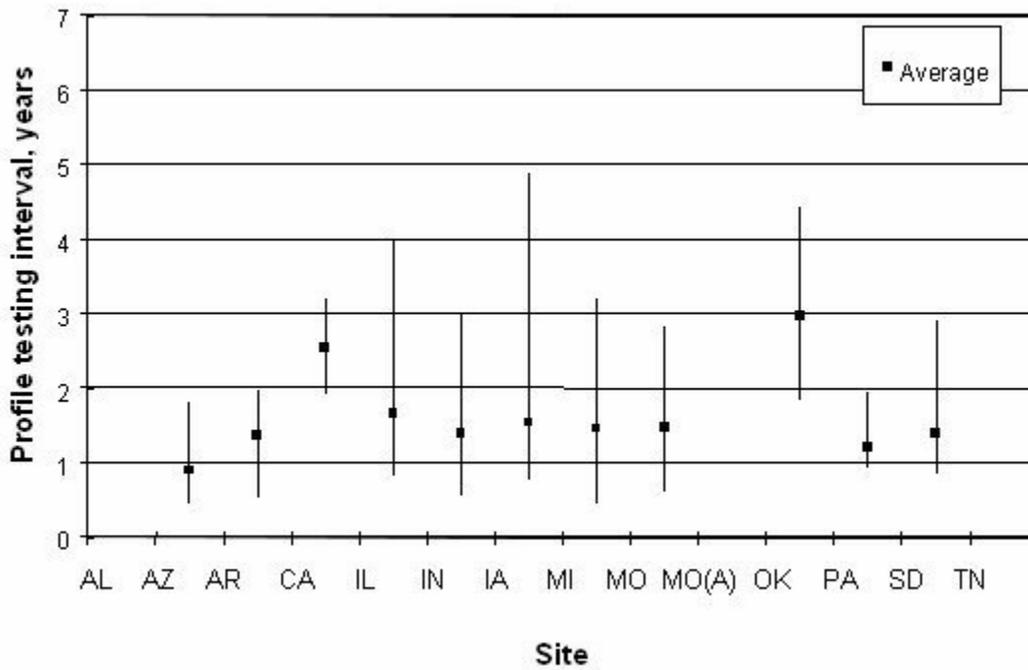
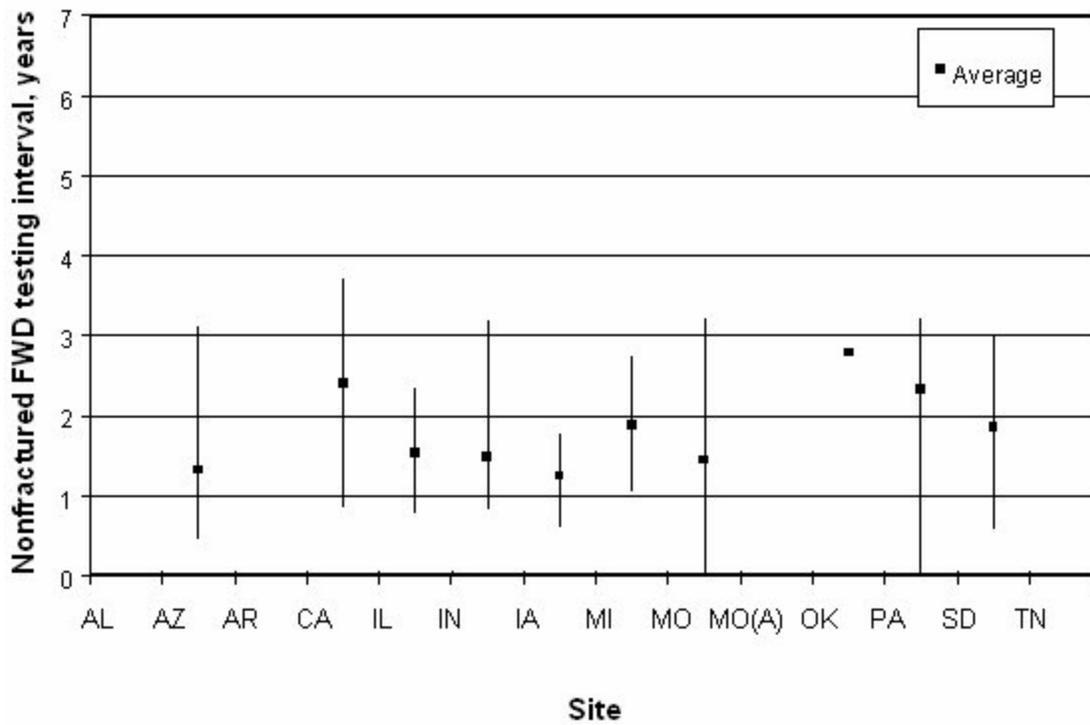
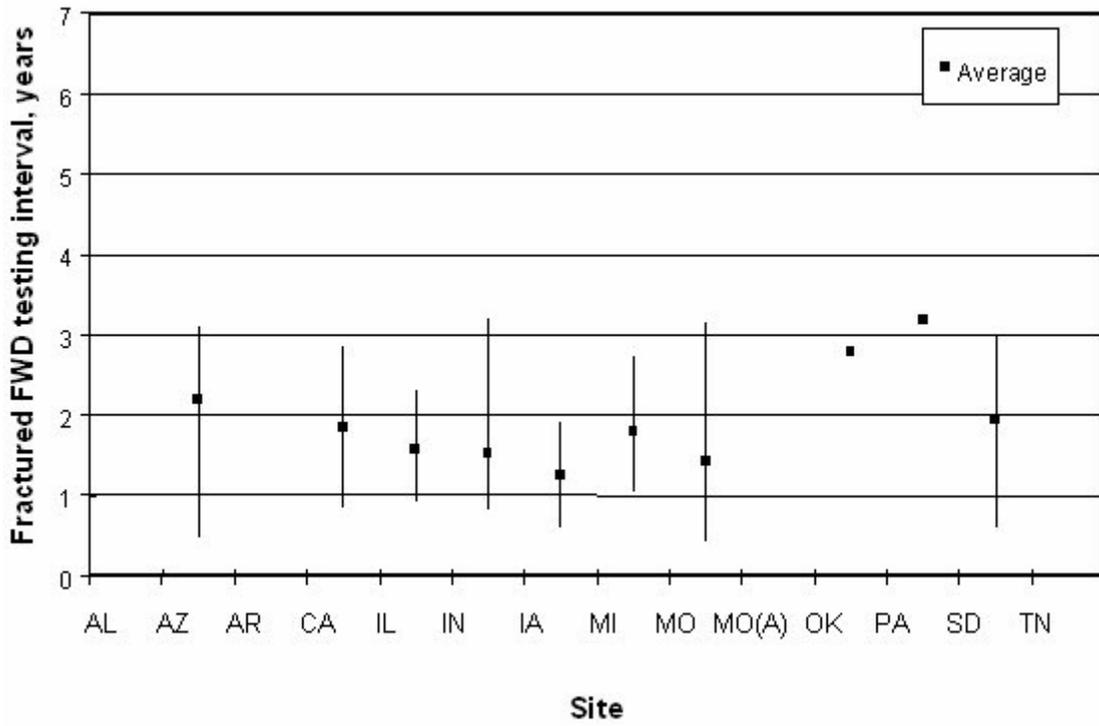
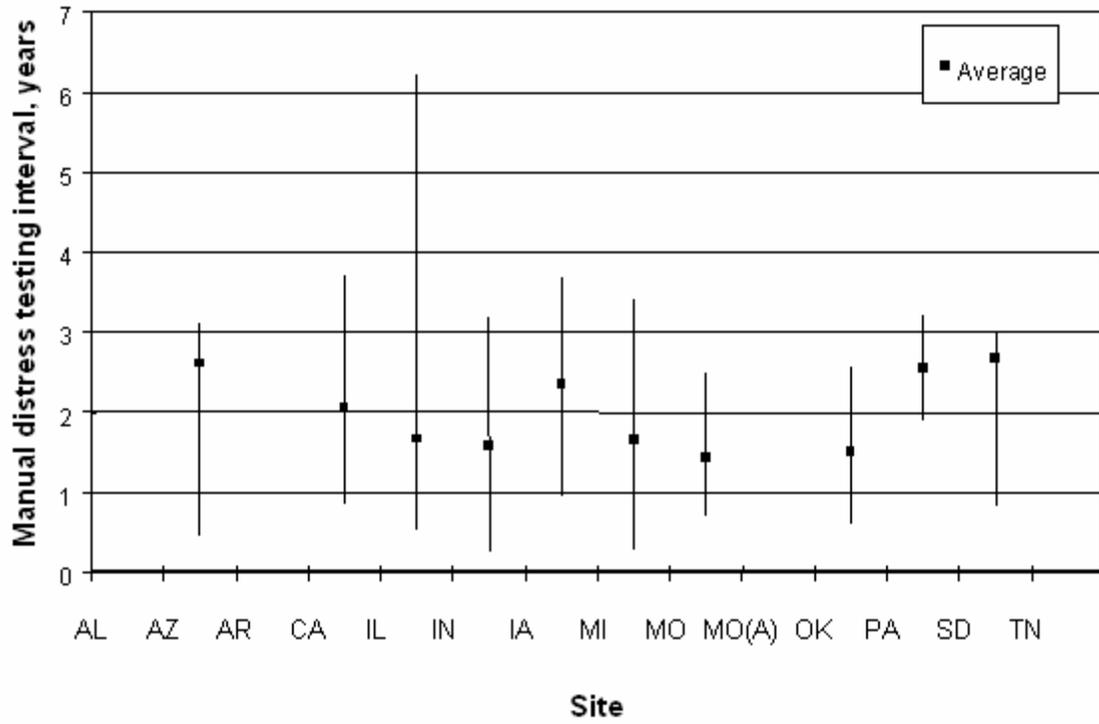
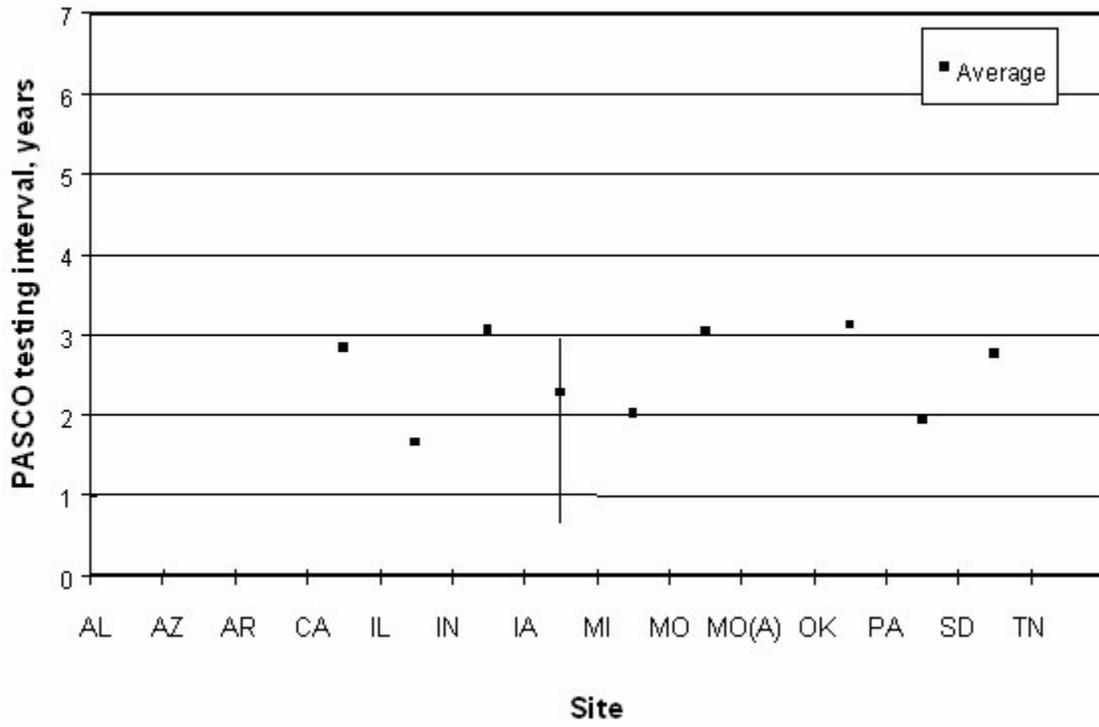
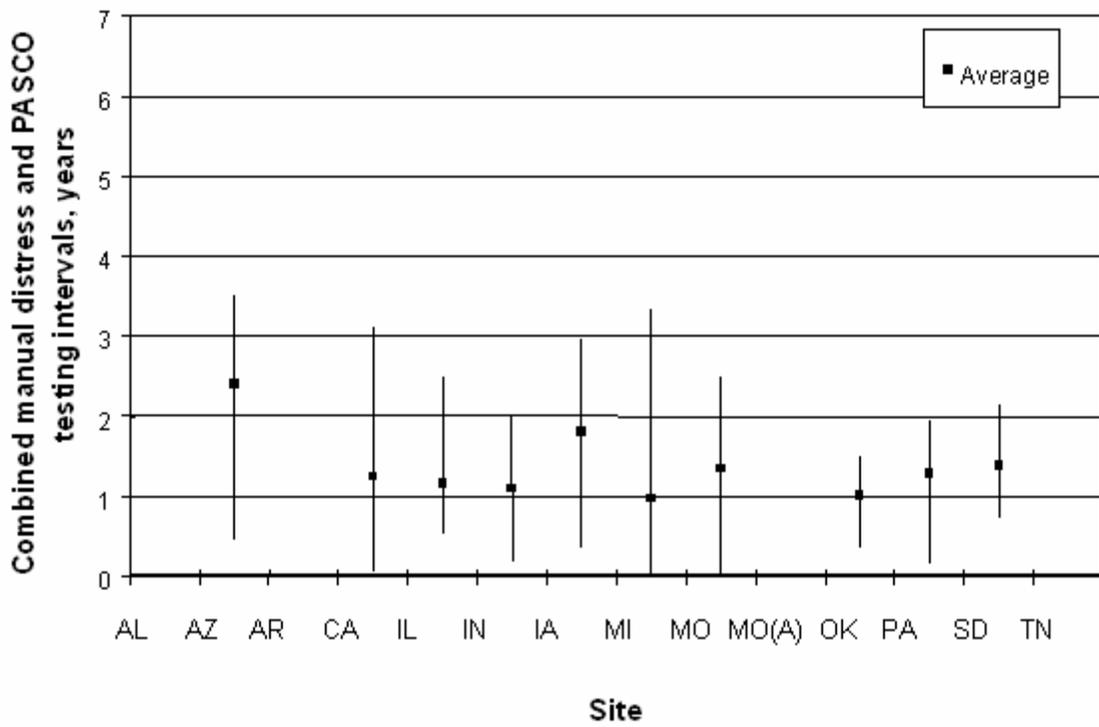
Figures 3 through 11 visually show the long-term monitoring intervals that were graphically presented in tables 21 through 29 for each of the data monitoring types. Each figure shows the long-term monitoring intervals for all sections of a particular site. This includes the minimum and maximum testing interval, and the average monitoring frequency that occurred at each site. Typically, all of the sections within a site were tested within a 3-year period.

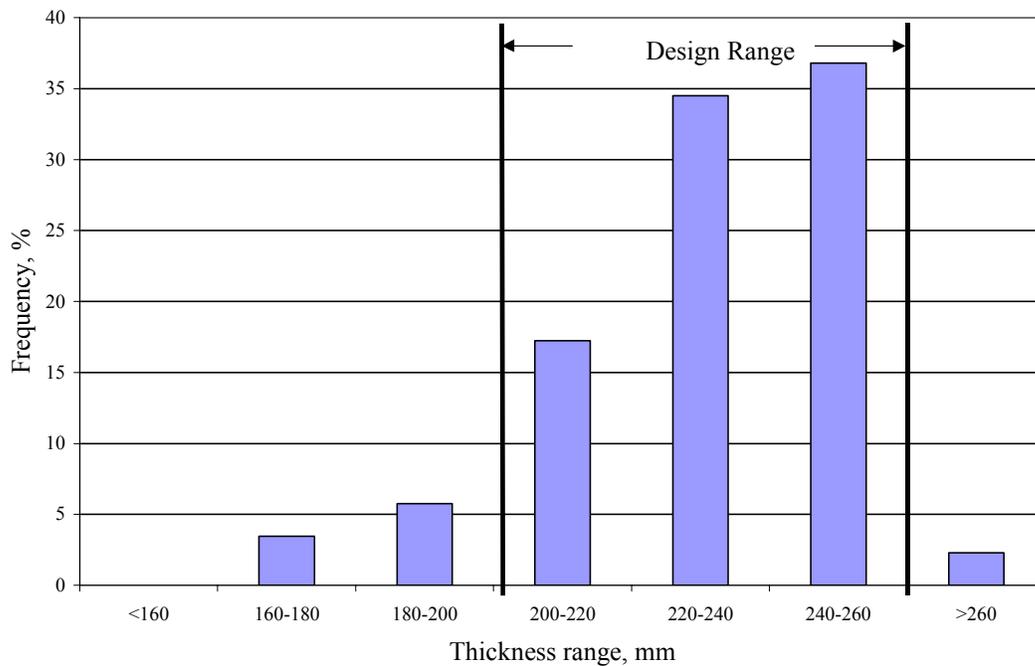
Figure 12. Frequency of PCC thickness.

Figure 12 visually illustrates the ranges of constructed PCC thicknesses for the core experiment sections. This figure shows that 9 percent (8 sections) were less than, 89 percent (77 sections) were within, and 2 percent (2 sections) exceeded the proposed design thickness range of 203 to 254 mm (8 to 10 inches).

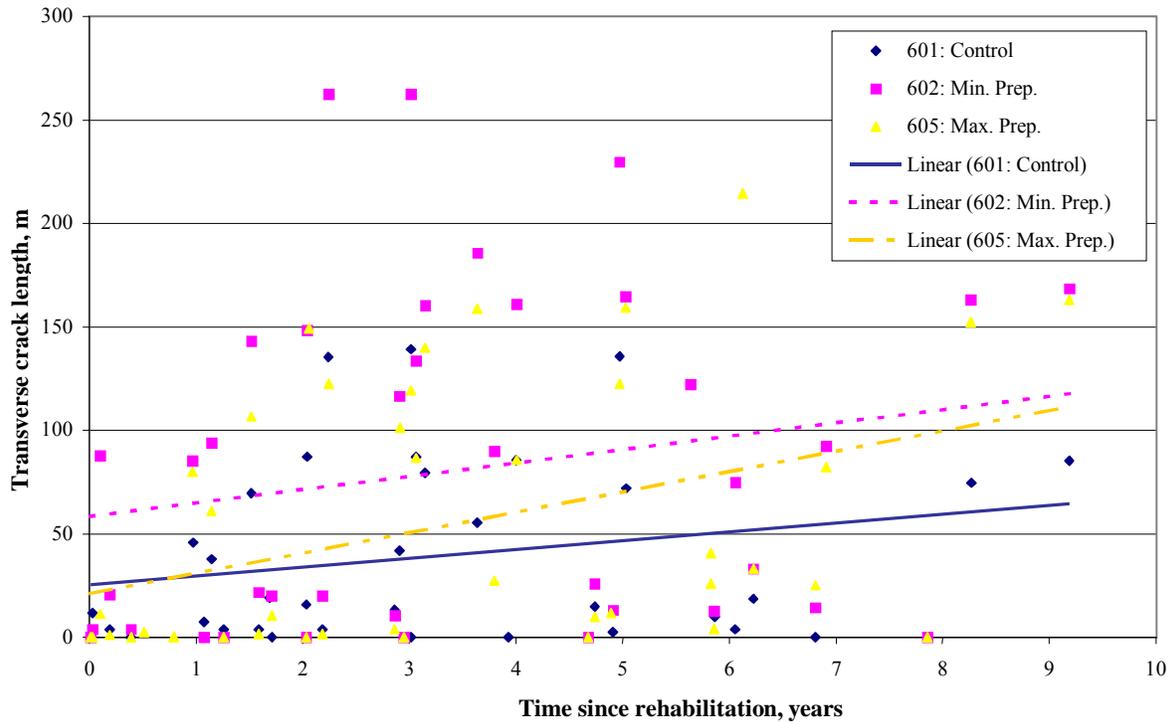
Figure 17. Total transverse cracking for bare PCC pavement sections.

Figure 17 shows the length of the transverse cracking for all three bare concrete sections. From this figure, it can be observed that cracking gradually increases with age and that the minimum- and maximum-preparation sections generally have more transverse cracking than the control section. The scatter is so great that this difference may not be significant.

It appears that the control section and the minimum-preparation sections have approximately the same increase in transverse cracking (slope) per year. It can also be noted that the maximum-preparation section has a higher rate of transverse cracking per year than the other two sections. There are no obvious reasons for this result, and a detailed analysis of each SPS-6 site is needed to ascertain the cause. The rate of increase in transverse cracking for each rehabilitation treatment will become more distinct as the pavement sections continue to age.

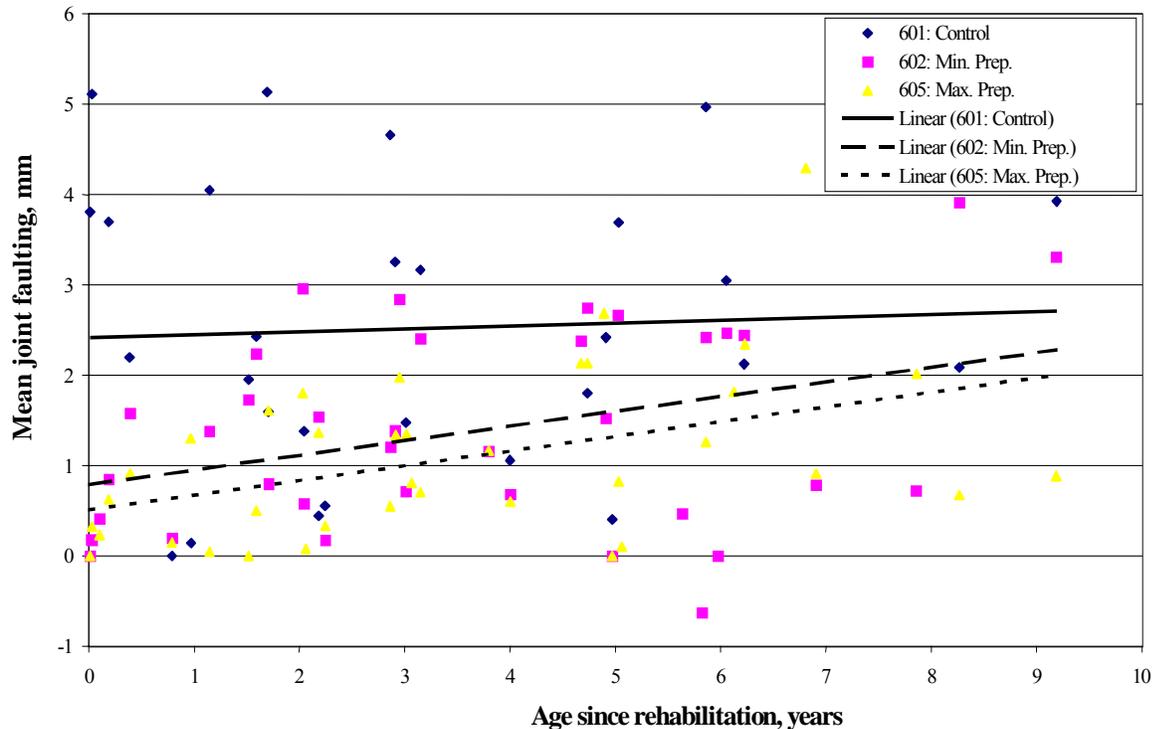
Figure 18. Mean joint faulting for bare PCC sections.

The average joint faulting values and their associated trends for the bare concrete sections are shown in figure 18. From this figure, it can be noted that there is very little increase in the amount of faulting for the control sections, while both the minimum- and maximum-preparation sections are showing an increase in faulting since rehabilitation occurred. Both rehabilitation alternatives can be projected to reach the same magnitude of faulting as the control section after about 10 to 12 years.

It is important to note that both the minimum- and maximum-preparation sections had reduced faulting values for several years after rehabilitation was completed because of diamond grinding, which reduces faulting to zero. The minimum-preparation sections, on average, had slightly more faulting than the maximum-rehabilitation alternative. This may be partially explained by the fact that most of the maximum-preparation sections had diamond grinding performed, while the minimum-preparation sections may or may not have had this treatment. At this time, it is difficult to tell if the increase in roughness (slope) for both the minimum- and maximum-rehabilitation treatments is significantly different. As these pavement sections continue to age, it is expected that the performance of the minimum- and maximum-preparation sections will become more distinct. These data trend lines show that the faulting of the maximum-preparation (with diamond grinding) sections will not equal the control section until after about 12 years.

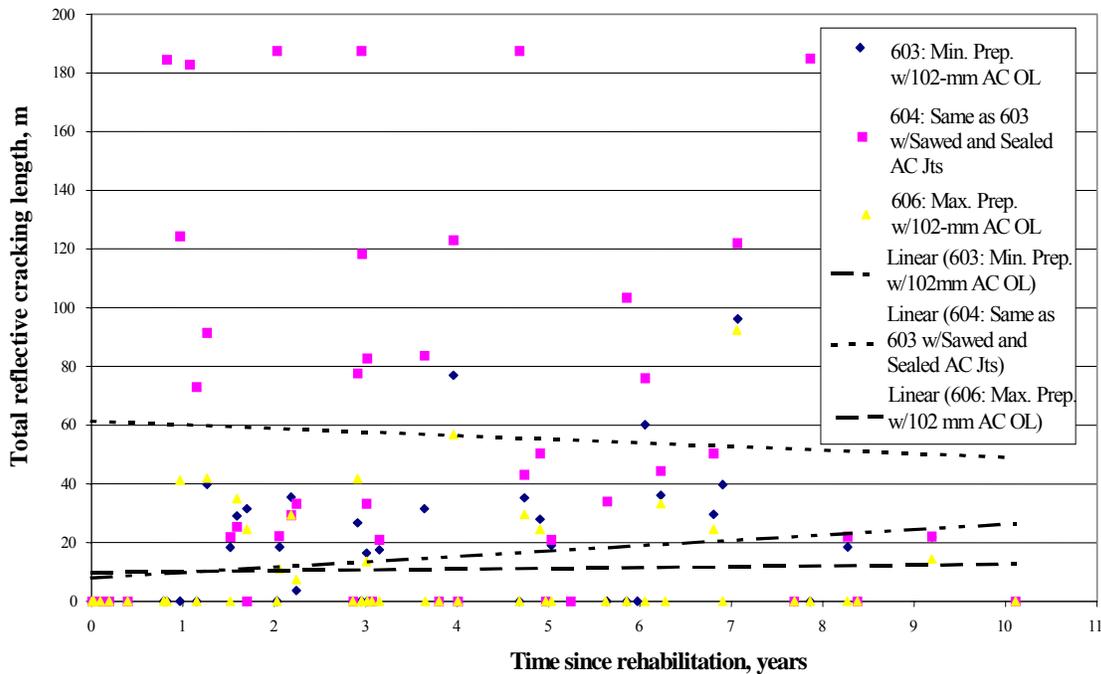
Figure 19. Total reflection cracking for nonfractured PCC pavement sections.

In addition, none of these sections exhibited reflection cracking during the first year following rehabilitation. However, it can be noted that most of the reflection cracking appeared during the second year after rehabilitation. Also, it can be noted that there is a relatively small increase in the length of the reflection cracking over time (slope of the line) for all of the rehabilitation techniques. Therefore, it appears that most reflection cracking will typically occur within a 2-year period after rehabilitation. In addition, the amount of reflection cracking does not

significantly increase after this period; however, it is expected that these cracks will continue to deteriorate.

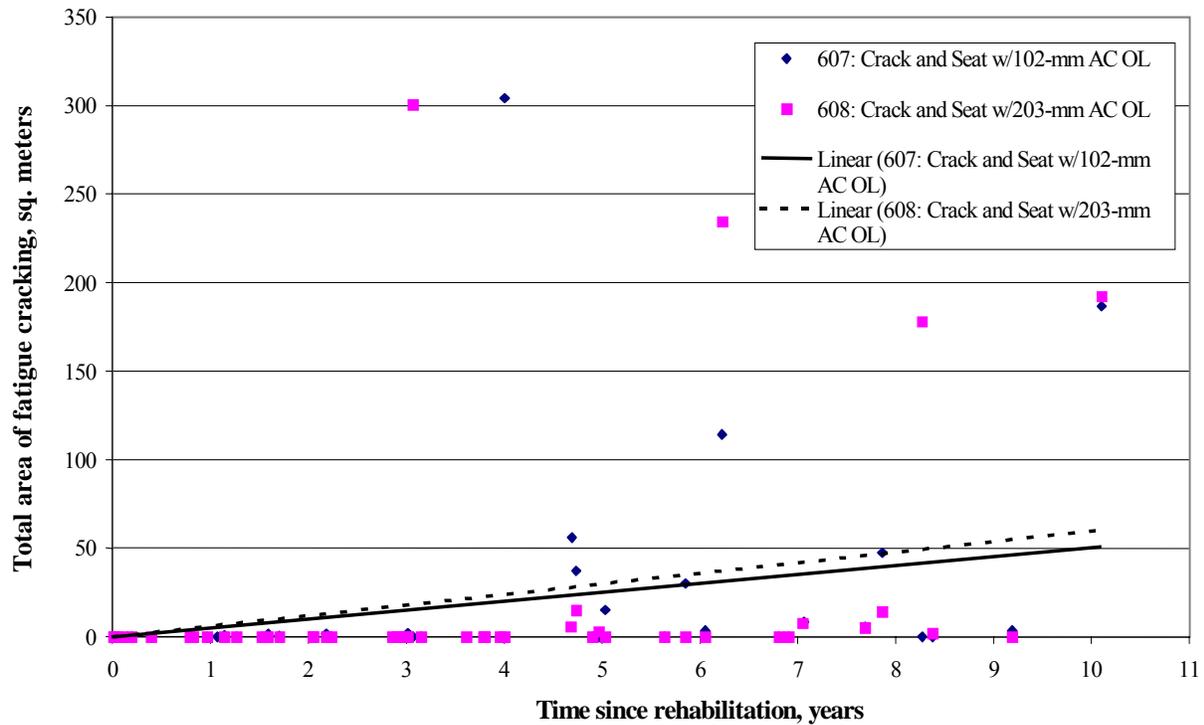
Figure 20. Total fatigue cracking for fractured PCC pavement sections.

Wheelpath fatigue and the associated trends for the AC overlay of fractured PCC pavements are shown in figure 20. Many of the fractured PCC sections have not exhibited any fatigue cracking since rehabilitation. However, some sections are showing a tendency toward fatigue cracking. Of those sections with fatigue cracking, it can be noted that the increase in cracking over time for both rehabilitation alternatives appears very similar. As these pavement sections continue to age, these performance trends will become more distinct.
